Manhole Inspection Summary

Manhole # S04YY1012MH

Location Address: **6507 WILLIAMSON AVE**

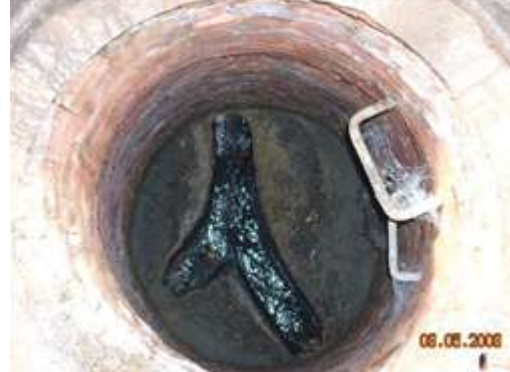
Top View

Corroded steps. Evidence of surcharge - Bench debris. Channel debris.

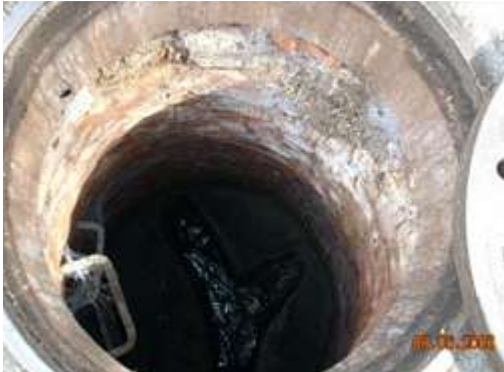
Defect

Frame leaks. Frame offset. Adjustment deterioration, , loose brick and infiltration. Barrel infiltration - other side.

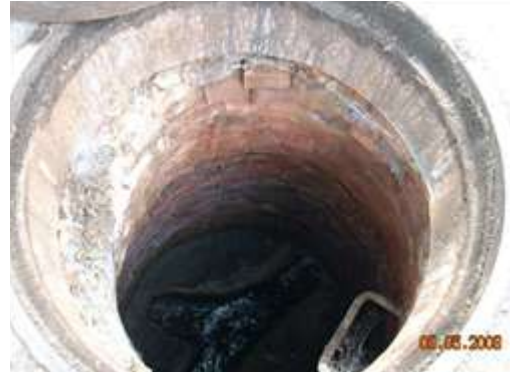
Defect

Frame leaks. Frame offset. Adjustment deterioration, , loose brick and infiltration. Barrel infiltration.

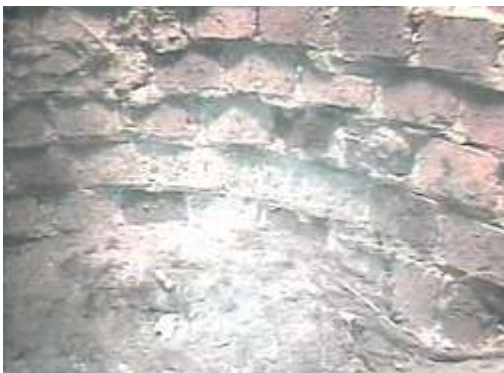
Defect

Barrel root intrusion and infiltration.

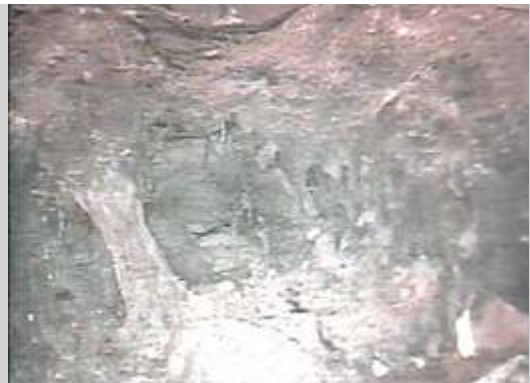
6 in. Circular Gravity Sewer

Capped.

Deposits: ☐ None ☒ **Mud** ☐ Sludge ☒ **Debris** ☐ Grease

Silt Depth: **4** (in.)

Deposits Extent: **Heavy**

Connects To: **Stub connection / abandoned**
